Preventing Engine Ingestion Injuries When Working Near Airplanes

By Fred Zimmer
Lead Engineer, Service Engineering, Propulsion

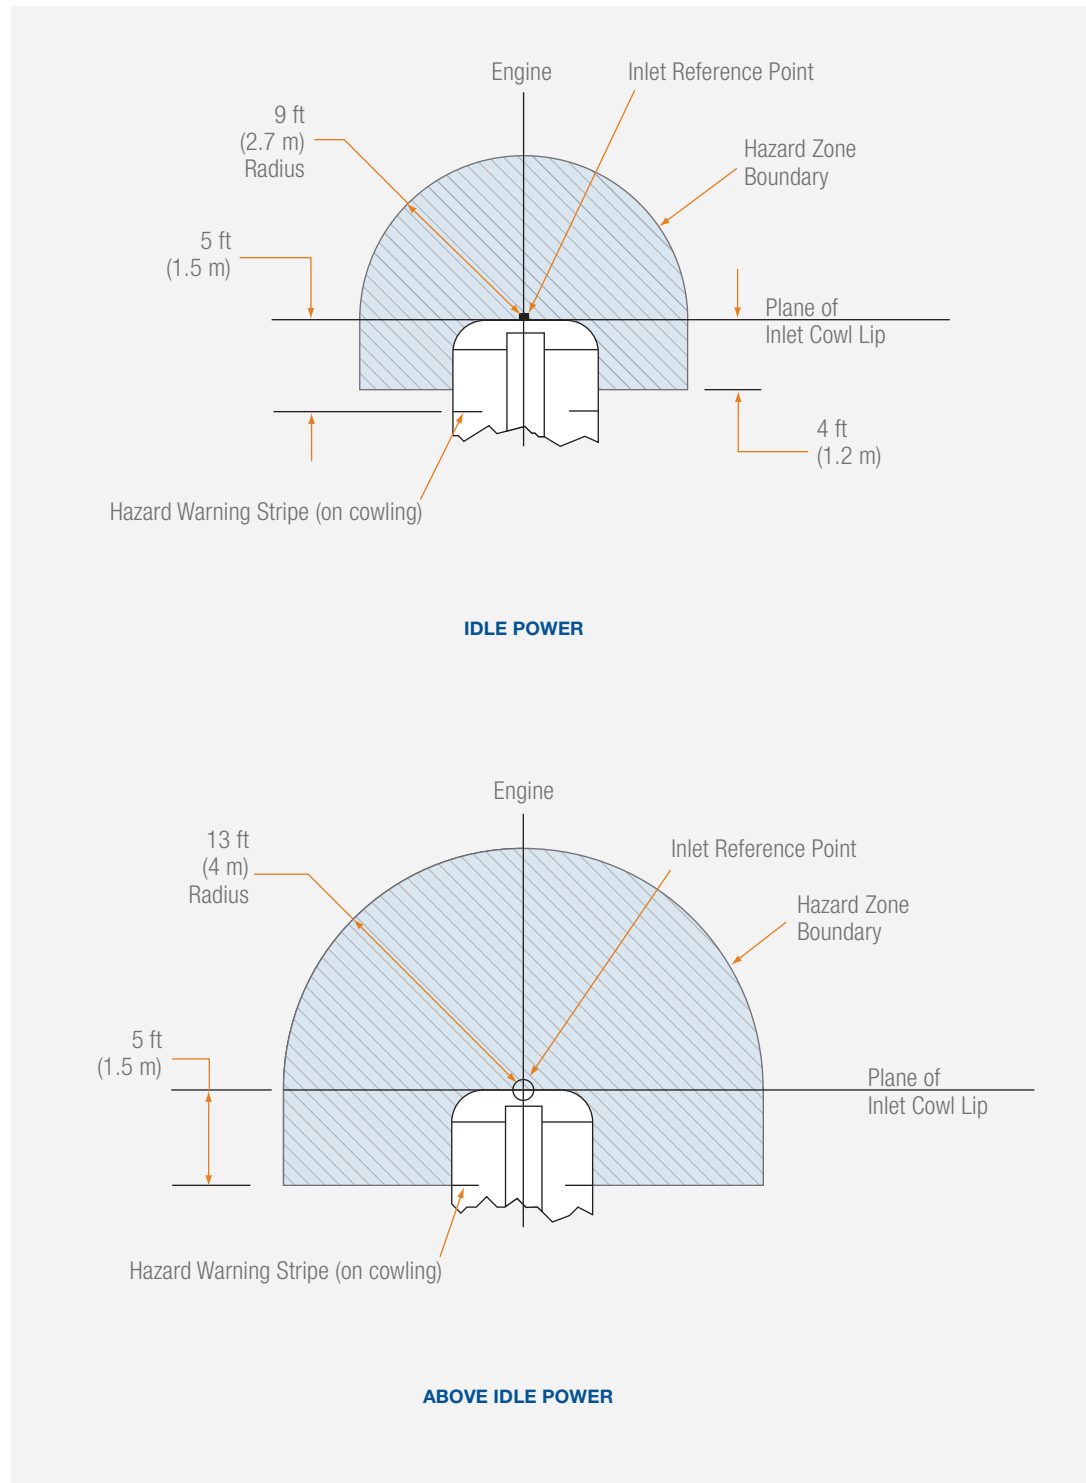
Figure 1

Engine inlet hazard zones for the 737-100/-200 and 737-300/-400/-500 at idle power (top) and above idle power (bottom).

All ground personnel who work near airplanes need to know the locations of the engine inlet hazard zones with engines at idle and above idle thrust (see figs. 1 and 2). Definitions for these zones are published in the AMMs.

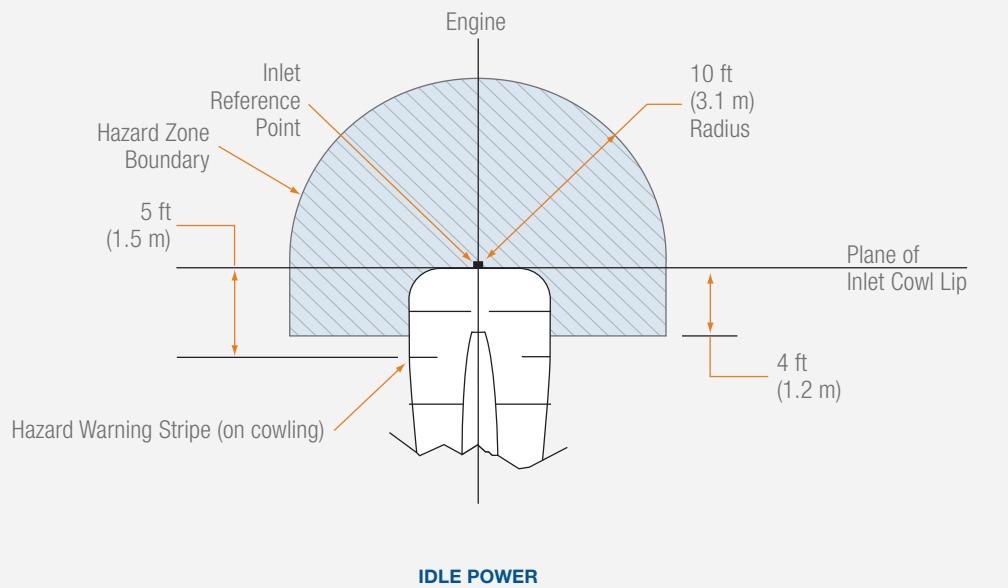
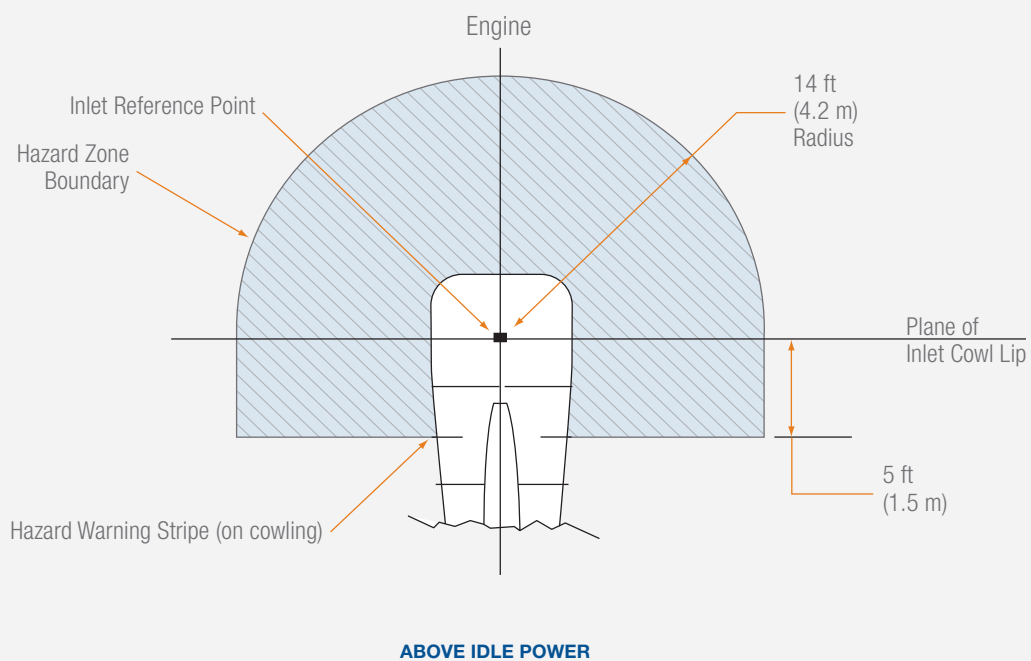
Figure 2

Engine inlet hazard zones for the Next-Generation 737 at idle power (top) and above idle power (bottom).

To further promote awareness of engine inlet hazard zones and provide ground personnel with a visual definition of the zones, some operators have painted engine inlet hazard zone boundaries on ramp surfaces at parking locations. If ramp surfaces are painted, Boeing recommends only painting hazard boundaries for above idle power to prevent any confusion that may result from different boundary areas. Operators also need to be aware that different hazard boundaries exist for 737-100/-200/-300/-400/-500 than for Next-Generation 737 airplanes. Any painted ramp

surfaces should reflect the larger above idle power Next-Generation 737 hazard boundary area if operators have multiple 737 derivatives in their fleets. Procedures should be established to ensure that airplanes are correctly parked in relation to the painted hazard zone boundary so that the inlet reference point of each engine is within the recommended tolerance. Additional information regarding hazard boundaries painted on ramp surfaces can be found in Boeing Service Letter 737-SL-71-028A, dated April 25, 2002.

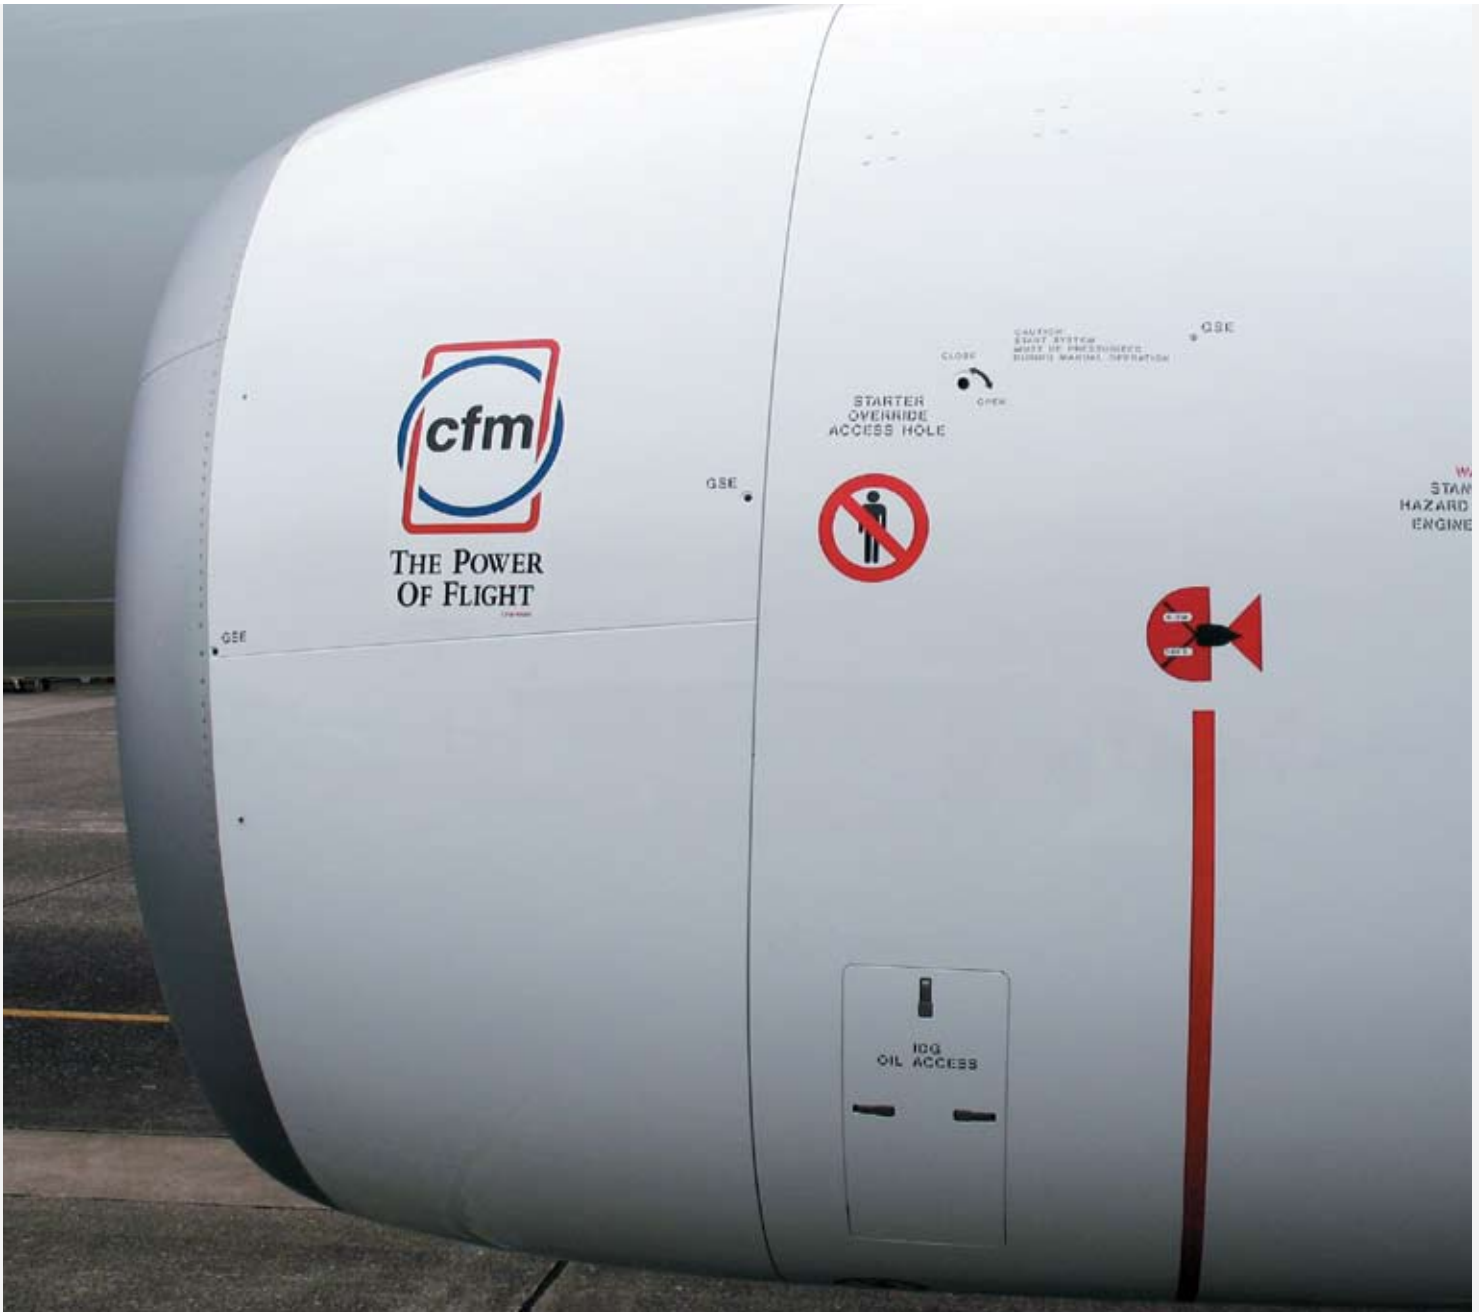
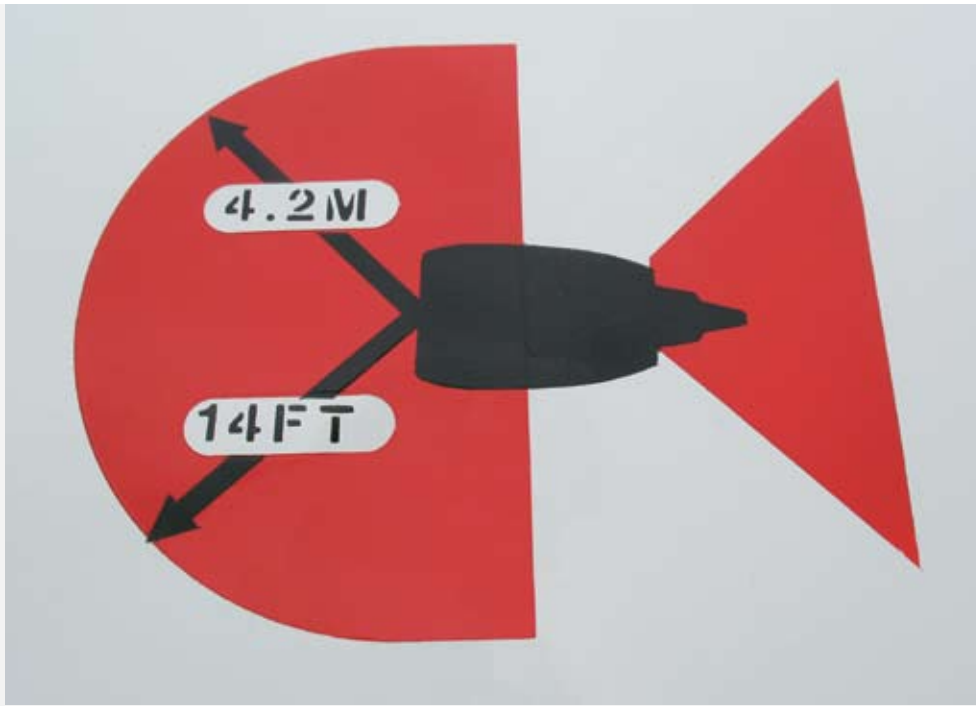
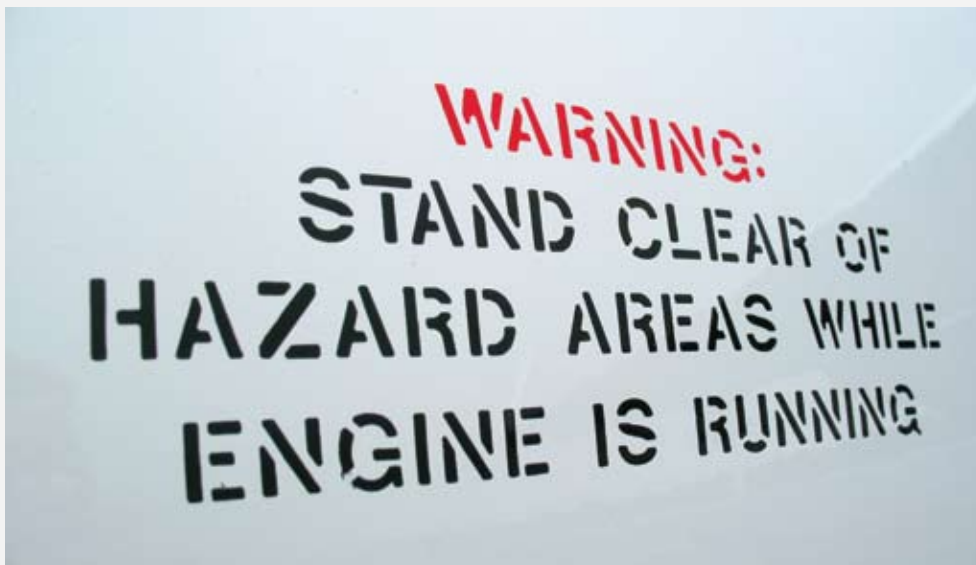
Figure 3

These hazard-area warning decals are located on both left and right engine nacelles. For the 737, hazard-area warning stripes and decals have been applied to all CFM56 engine nacelles prior to delivery. Inlet hazard-area warning stripes and decals were applied to all JT8D engine nacelles prior to delivery beginning with airplanes delivered in May 1984. Boeing Service Bulletin 737-11-1010, Revision 1, dated June 21, 1985, provides for retrofit application of warning stripes and decals on JT8D engine nacelles delivered prior to this date.

All 737-300/-400/-500 and Next-Generation 737 airplanes at delivery have Boeing-applied hazard-area red warning stripes, above-idle hazard-area decals, and “no-entry” decals applied to the engine nacelles (see fig. 3). Similar hazard-area warning stripes and decals were also applied to all 737-100/-200 airplanes beginning with Line Position 1020, which was delivered in May 1984. For 737-100/-200 airplanes prior to Line Position 1020, hazard-area warning stripes and decals can be applied per Boeing Service Bulletin 737-11-1010 Revision 1, dated June 21, 1985.

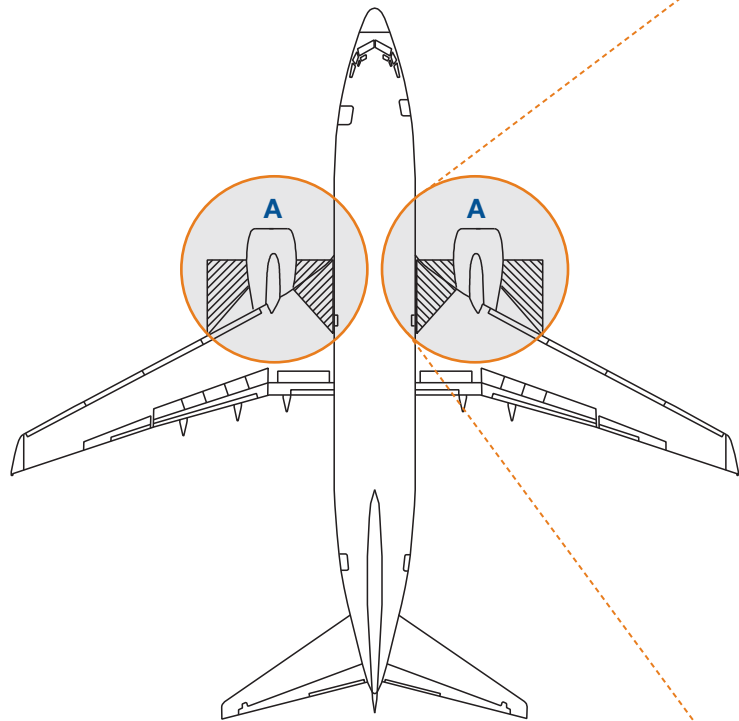
Figure 4

Ground personnel must use only the designated entry/exit corridor when it is necessary to be near an operating engine. (The Next-Generation 737 is shown; 737-100/-200/-300/-400/-500 entry corridors are similar.)

If it is necessary for ground personnel to be near the engine during an engine operation (such as during an idle leak check or to disconnect the ground air cart), they should make sure that the engines are at minimum idle and use only the entry/exit corridor to enter and exit the fan case area (see fig. 4 for Next-Generation 737

airplanes). Similar 737-100/-200/-300/-400/-500 entry corridors are identified in the applicable AMM. Inlet screens and a Boeing-approved personnel safety harness (part number F8023912) can be used for additional protection. Correct use of the safety harness is described in the AMM.
