Stress test

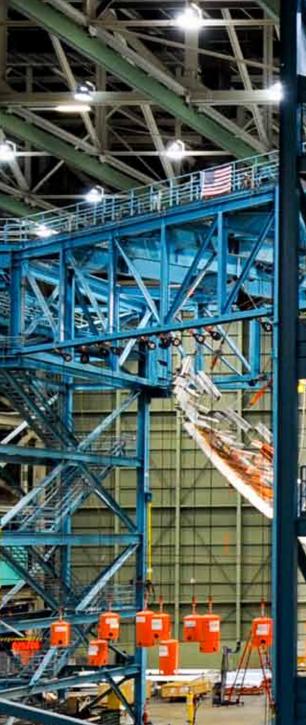
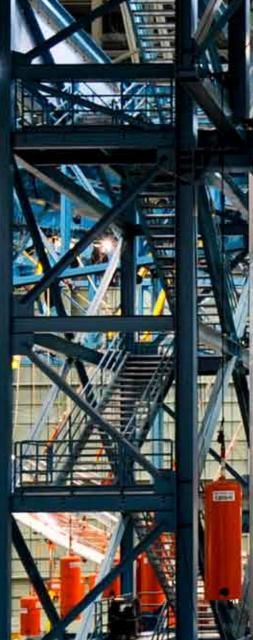
During a key test in March at Boeing's factory in Everett, Wash., the composite wings of the 787 static test airplane were bent upward until they experienced 150 percent of the most extreme forces, or ultimate load, the airplane is ever expected to encounter during service. At the same time, the composite fuselage of the Dreamliner was pressured to 150 percent of its maximum normal operating condition. When this photo was taken, the 787 wing tips were at the maximum point of deflection, about 25 feet (7.6 meters) from normal. A detailed analysis of data collected during the test found the 787 met all requirements and performed as designed. PHOTO: JENNIFER REITZ/BOEING
