Preventing Engine Ingestion Injuries When Working Near Airplanes

By Fred Zimmer
Lead Engineer, Service Engineering, Propulsion

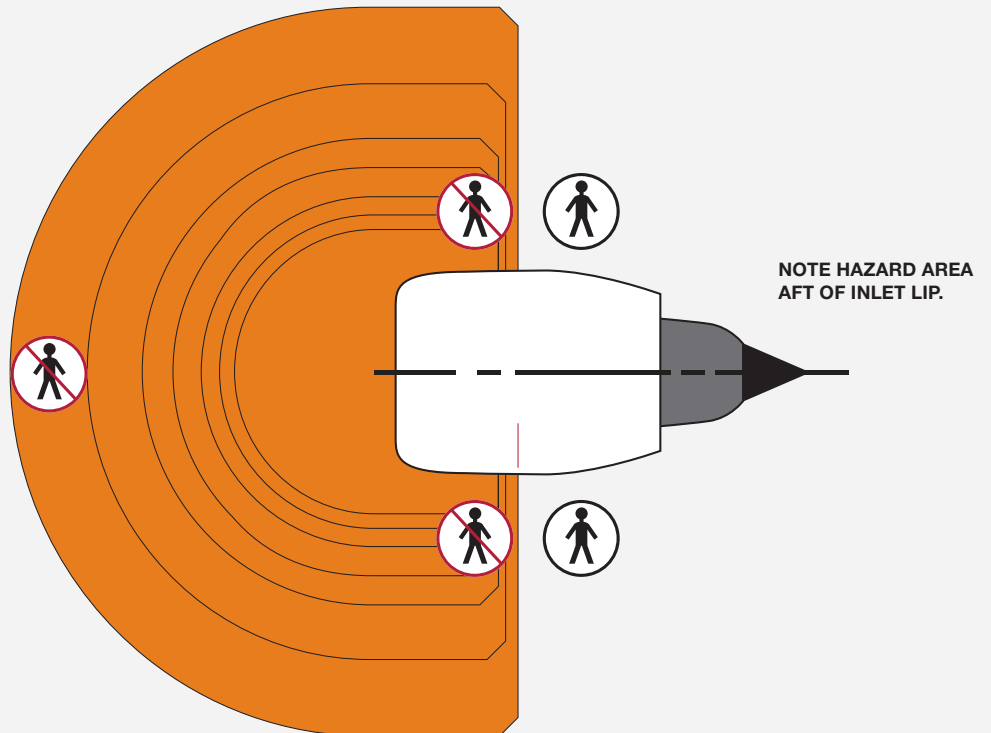
INLET SUCTION FORCES ARE HARDLY NOTICEABLE BEYOND THE INLET HAZARD AREA BUT INCREASE DRAMATICALLY WITH EACH STEP INTO THE HAZARD AREA.

BE AWARE OF ENGINE INLET HAZARD AREA. ONE MISSTEP INTO THESE AREAS AND IT MAY BE YOUR LAST.

DO

- Do know the proper hazard areas as stated in the maintenance manuals.
- Do secure loose items on person or remove them.
- Do tread carefully, guard against tripping or stumbling.

- Do not wear loose clothing.
- Do not attempt to retrieve items in hazard area.
- Do not gesture with arms.
