# Orbital care

When a cooling problem threatened the space station, Boeing teams worked together to help find solutions

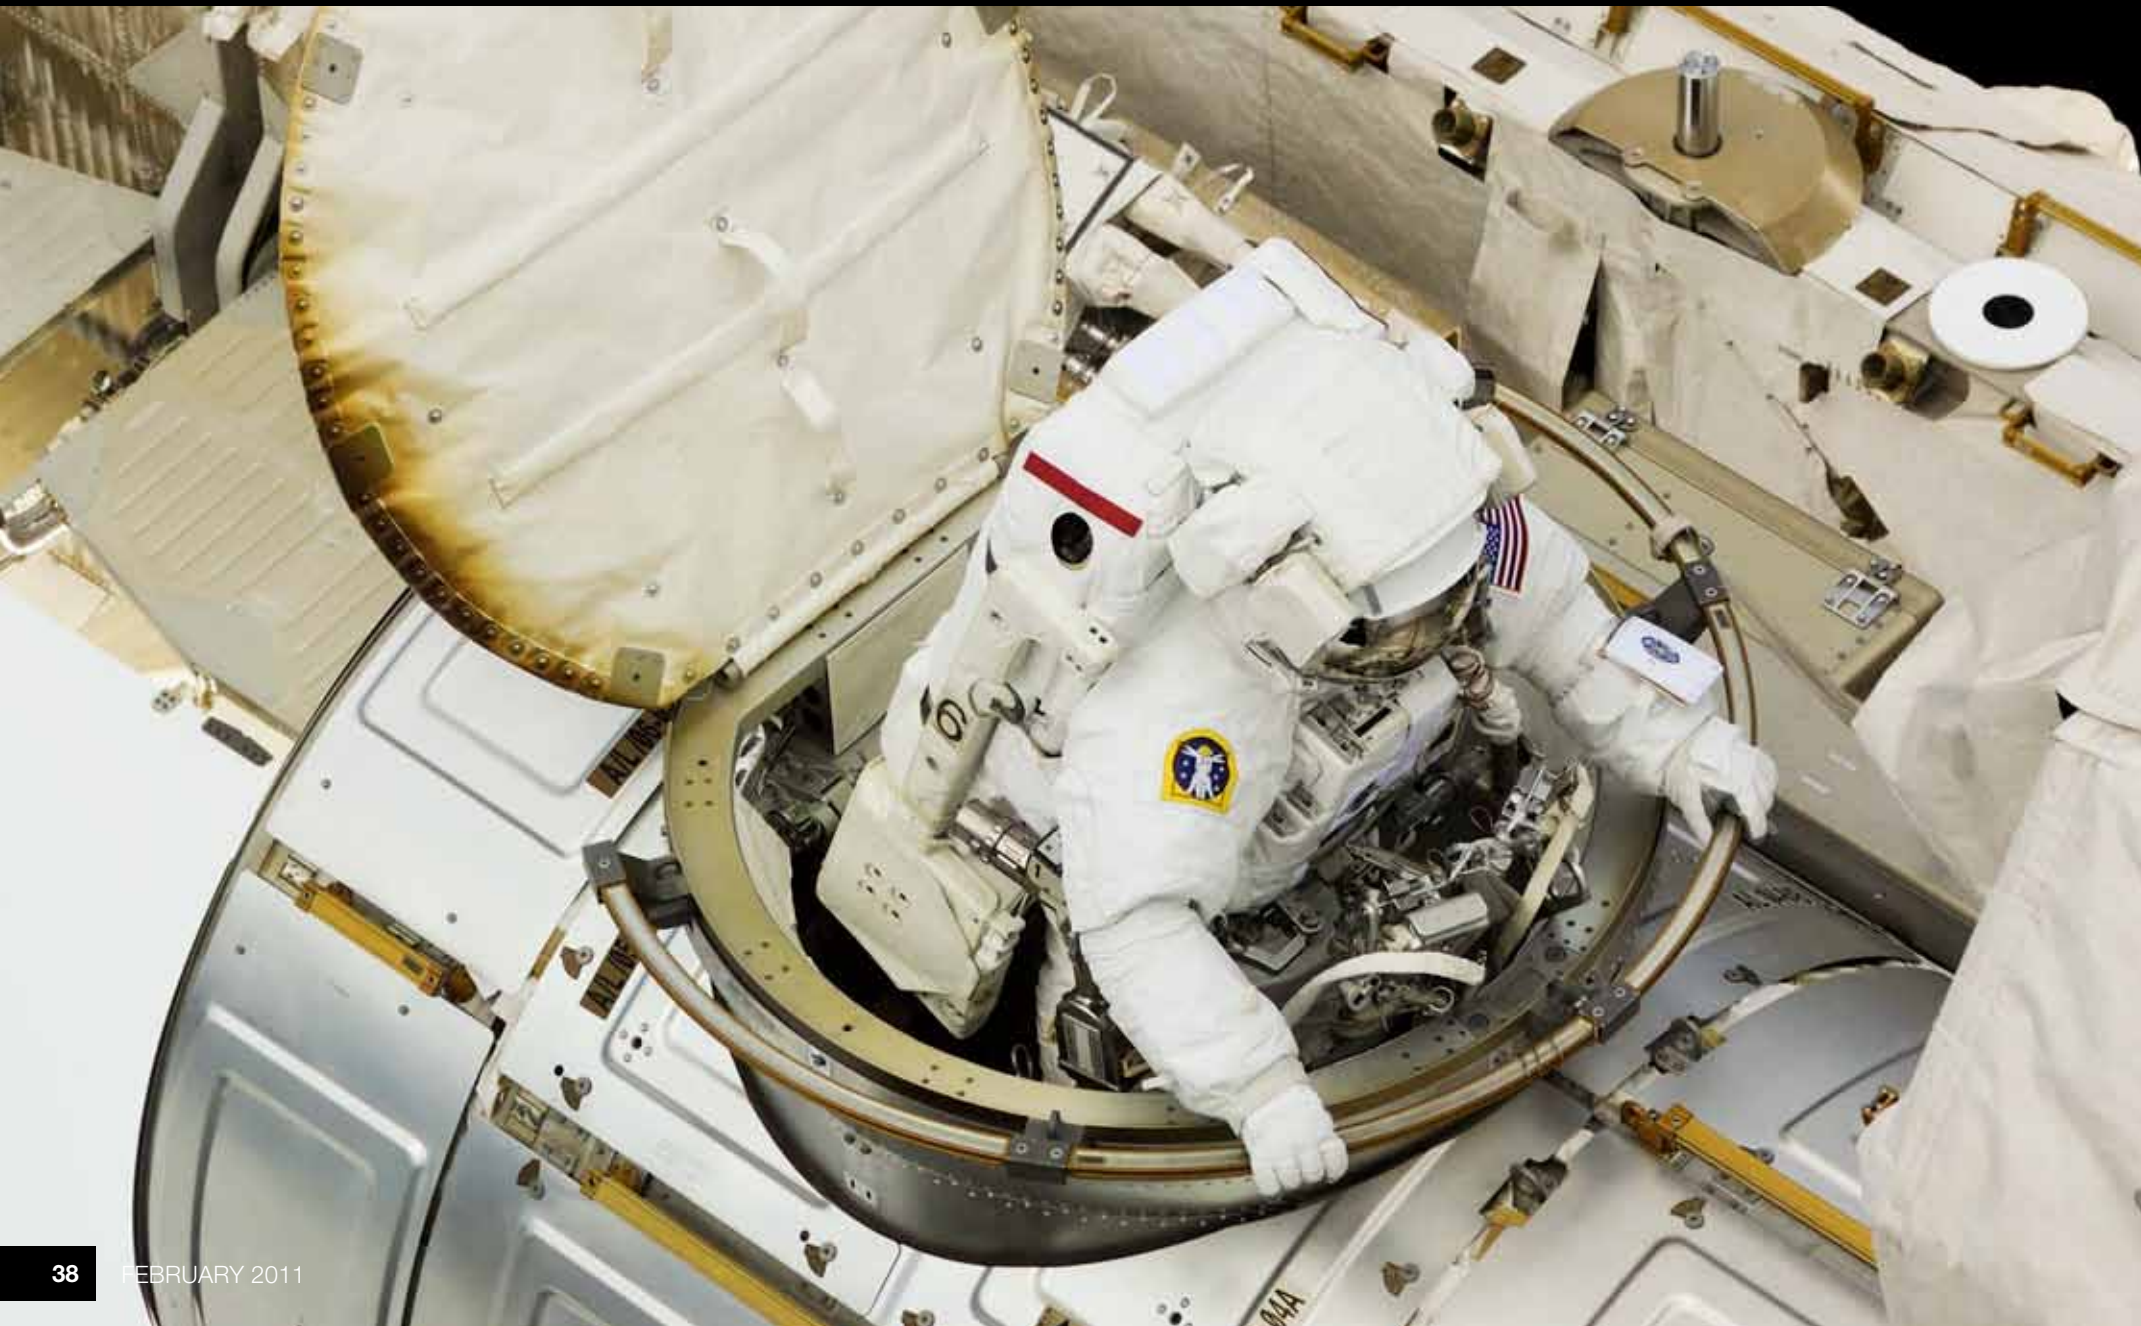
**PHOTOS: (Left)** Astronaut Doug Wheelock emerges from the space station for the second of three spacewalks last August to remove a failed ammonia coolant pump module on the station's S1 truss. **NASA (Below)** Boeing VIPeR team members Mark Krajchovich (left) and Suzanne Oliason are ready with Boeing support in NASA's International Space Station Mission Evaluation Room. **ELIZABETH MORRELL/BOEING**

Because the failed ammonia pump module was so large, it had to be temporarily stowed on the station's Mobile Transporter to make room for the crew to install the new pump. Placing such a large piece of equipment in a new location on the station's structure meant the team needed to develop new mass properties for the station.

During the spacewalks, ammonia and nitrogen were vented from the ammonia pump lines. In the vacuum of space, these gases turn into hard particles that can cause significant damage if they hit the station.
